NSWCCD-65-TR-2003/38 September 2003

SIDER Testing of a Damaged Section of Mast from the *Mirabella V* Superyacht

This report presents the results of a single Structural Irregularity and Damage Evaluation Routine (SIDER) inspection of one section of the new mast of the *Mirabella V* superyacht. The section that was tested had known manufacturing defects. Prior to the SIDER testing, the decision had been made by VT Halmatic Limited, Portchester Shipyard, Hamilton Road, Portsmouth, UK to remake the component. Therefore, the work reported here was conducted on a structurally unacceptable component that was not going to be used in service.

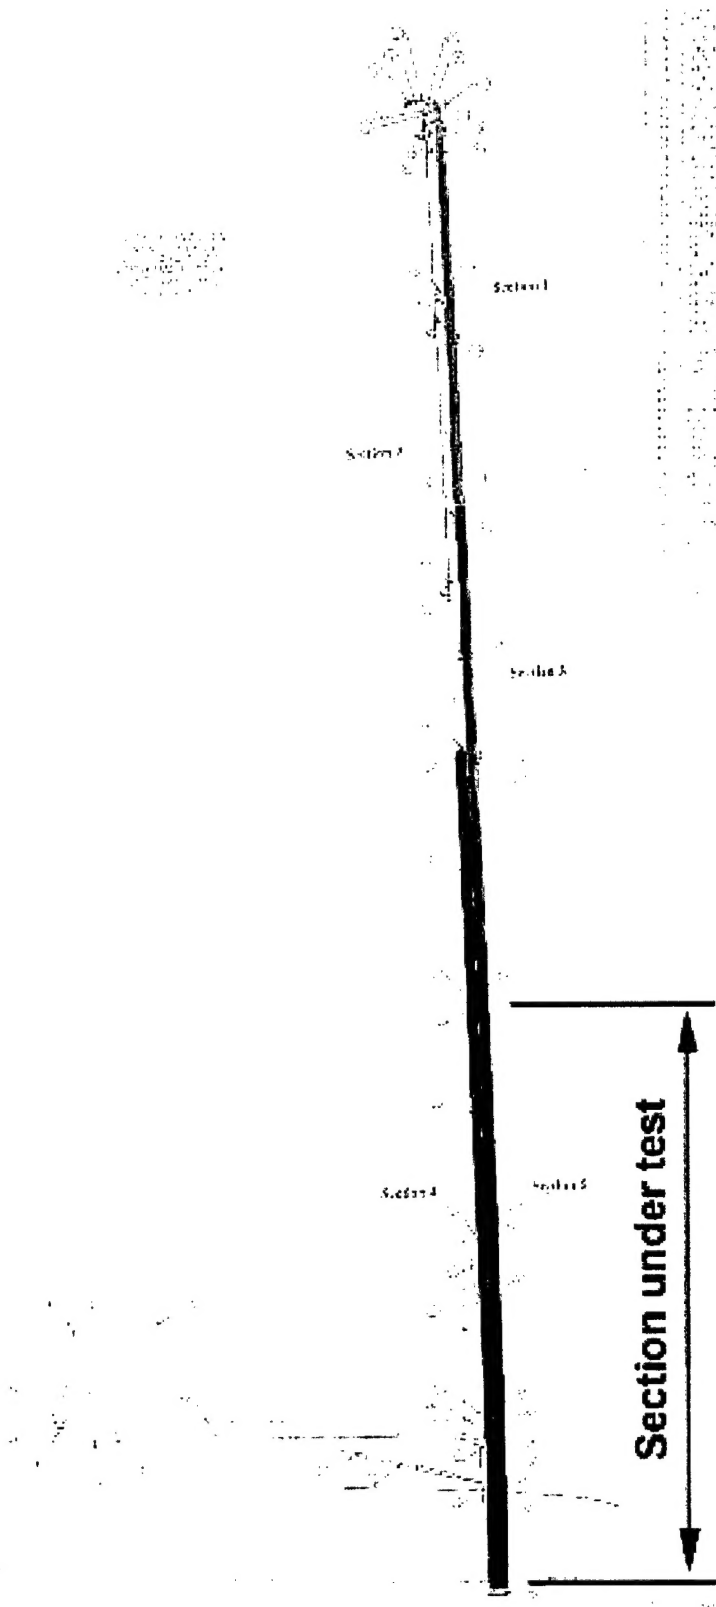
Figure 3. Drawing Showing the Section of the Mast that Was SIDER Tested

The overall length of the mast section was 120 feet. The part that was SIDER tested was from 59-feet 5-inches to 99-feet 2-inches from the mast base. Figure 6 shows the test grid with grid point numbering. In this figure, the bottom of the mast section is 59-feet 5-inches below the bottom of the figure (that is, below the row of grid points #12-#19).

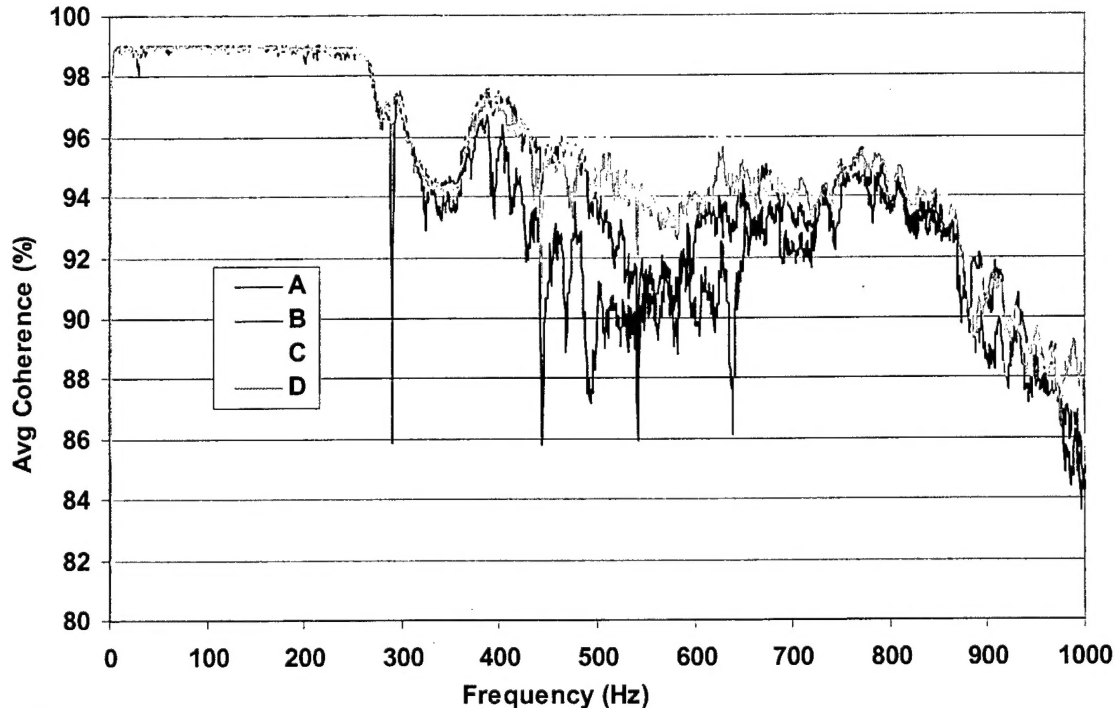
Figure 8. Average Coherence

After the fact, the data quality is assessed by the average coherence. Figure 8 shows the average coherence. In keeping with our standard procedures, the average coherence is shown separately for each transducer. In this way, instrumentation or local structural problems can

sometimes be identified. Note that the Coherence axis for each graph is expanded, and only shows the range 80-100%. We would normally consider a high quality data set to have an average coherence in excess of 95%, and preferably more than 98%. We have very high-quality data up to about 250 Hz, as expected from the input energy frequency range.

The conclusion drawn is that all the transducers recorded data of a high quality, although, as is normally expected, the data at the highest frequencies have reduced quality. This is because the hammer impact did not put sufficient energy into the structure at these high frequencies to get the response signals sufficiently out of the noise threshold.
